# Landsat 7 Anomaly Status

**Jim Irons**

**Landsat Data Continuity Mission Project Scientist  
NASA Goddard Space Center**

**LP DAAC Science Advisory Panel Meeting  
USGS Headquarters, Reston, VA  
September 10, 2003**

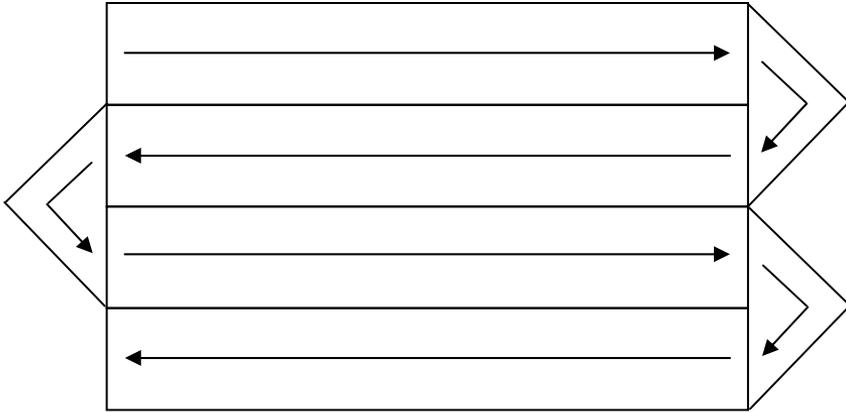
With SLC

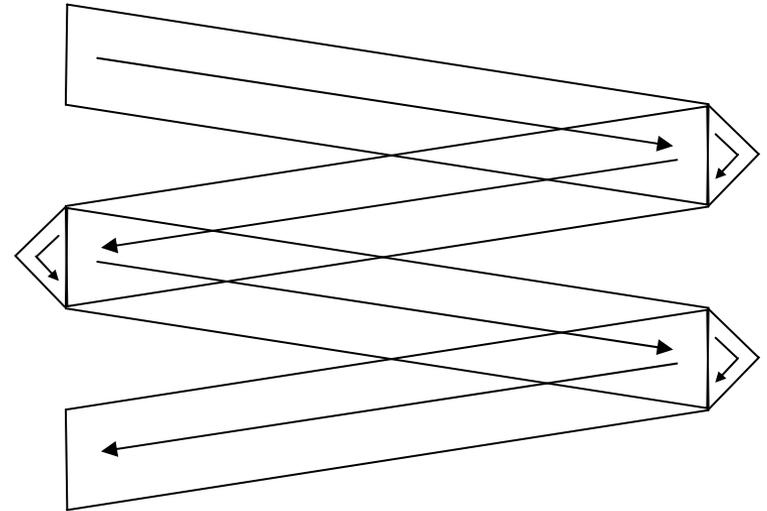
Without SLC

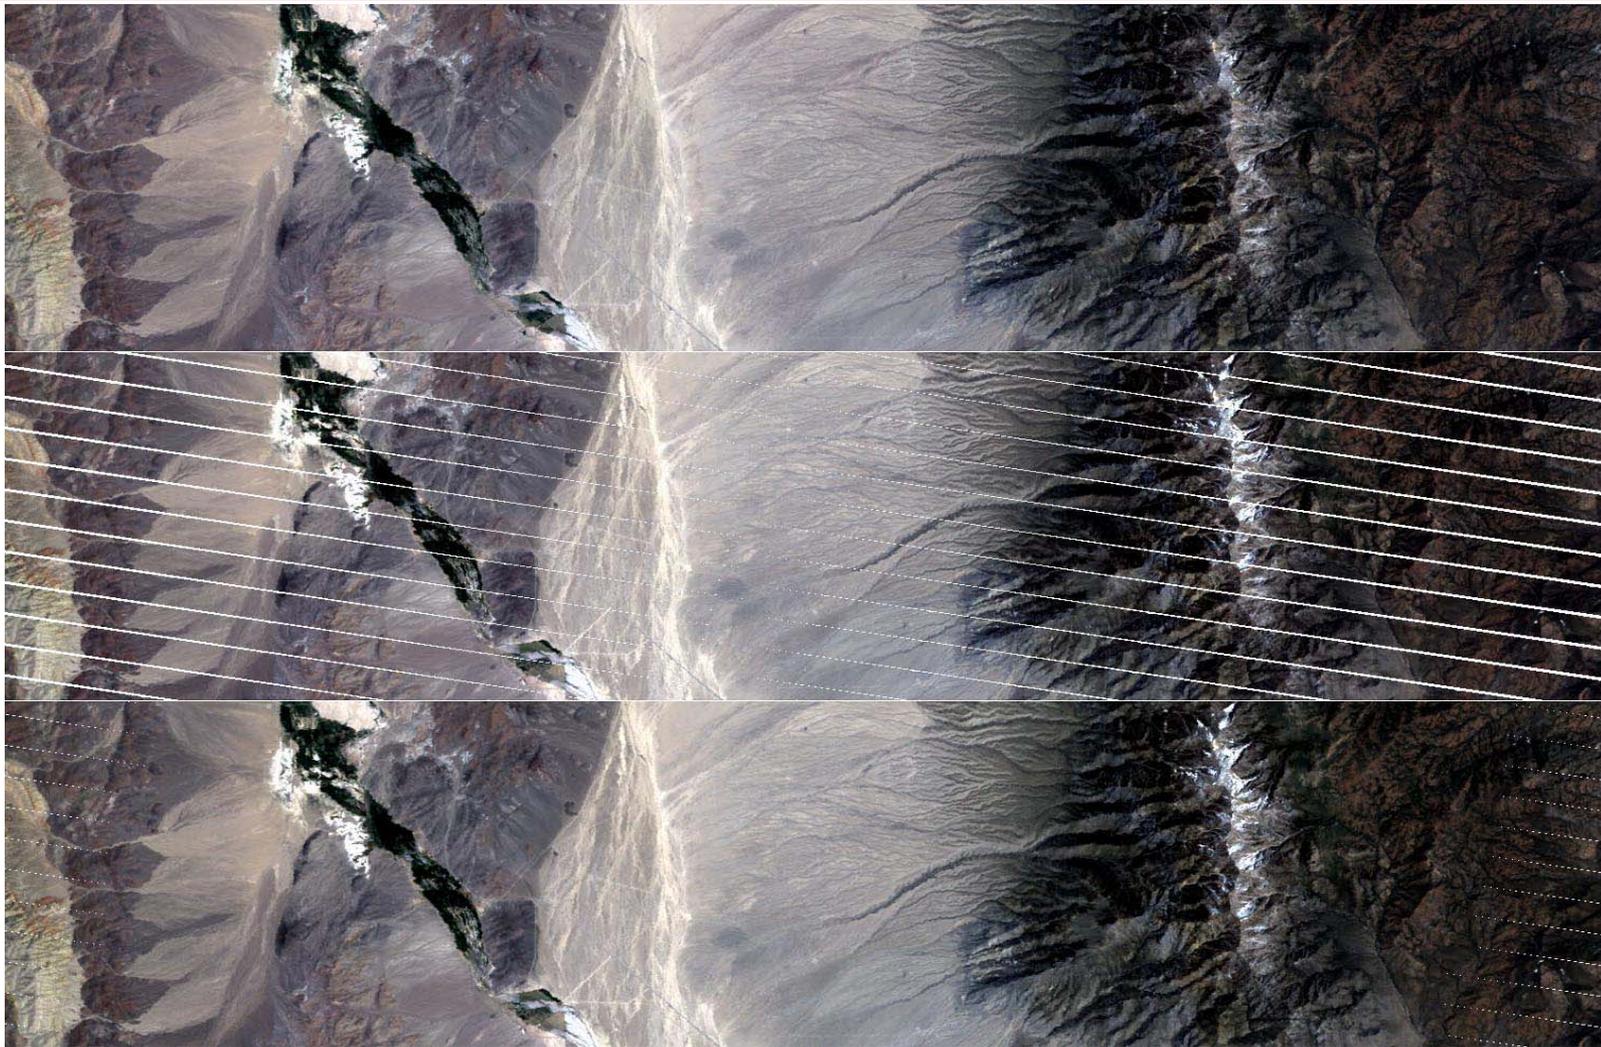
## Impact of Stopped SLC (near center of image)

SLC

NO  
SLC

No  
SLC  
With  
interp
